**D0875.02-113-11-R0**  
**ACOUSTICAL PERFORMANCE TEST REPORT**  
**ASTM E 90 and ASTM E 492**

**Series/Model: QT4005**

**Specimen Type: Floor/Ceiling Assembly**

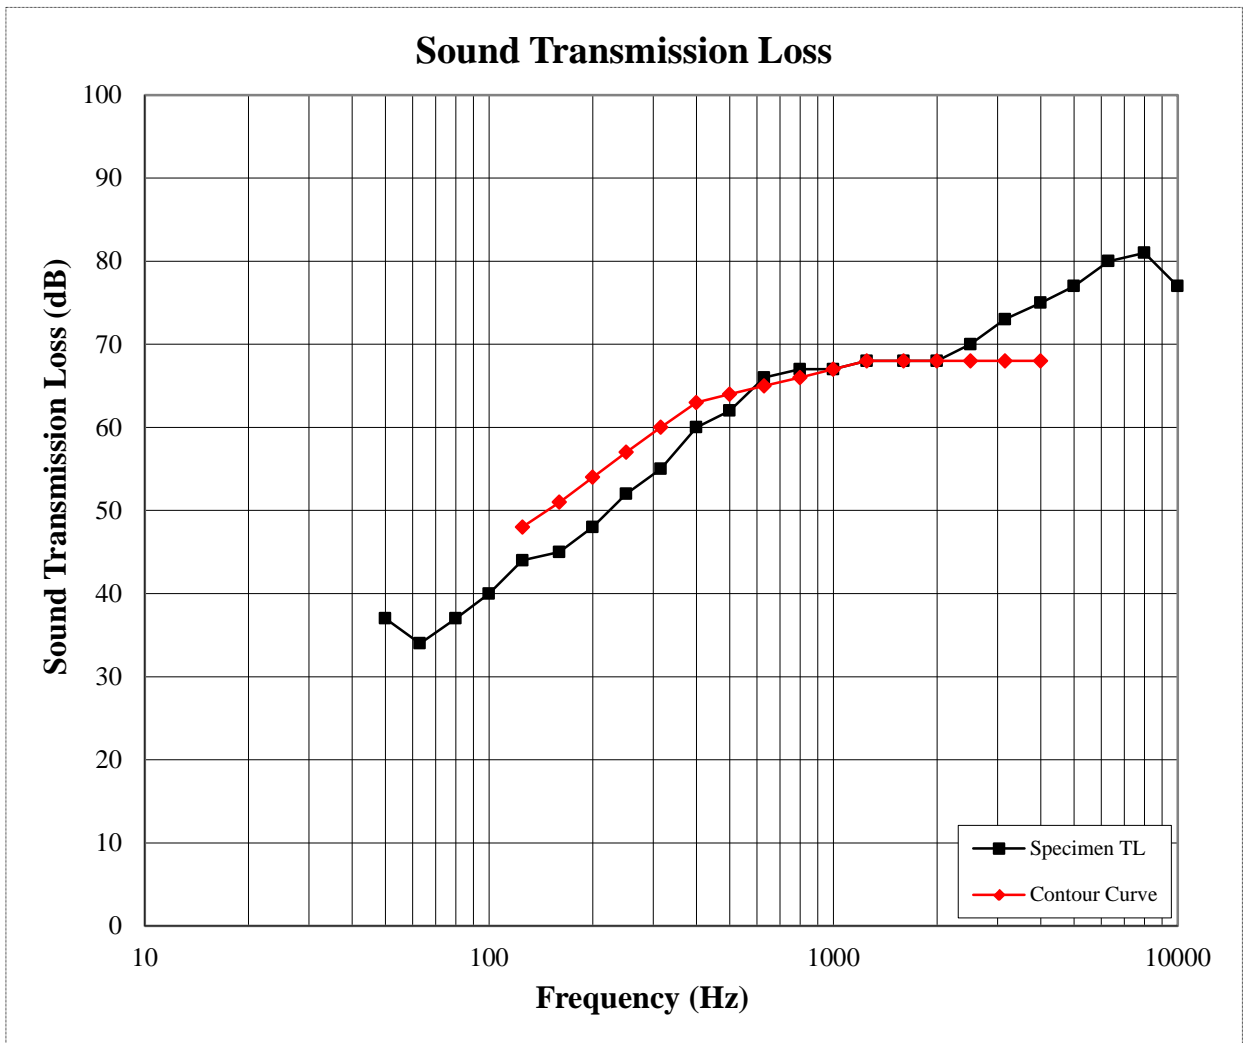
**SOUND TRANSMISSION LOSS**  
ASTM E 90

<b>Test Date</b>	10/17/13
<b>Data File No.</b>	D0875.02A
<b>Client</b>	ECORE International
<b>Description</b>	7 mm Ceramic Tile, 8 mm Cement Board, 5 mm ECORE International QT4005 Underlayment, 18.3 mm T&G OSB Subfloor, 457 mm Open Web Truss, 165 mm R-19 Fiberglass Insulation, 13 mm RC Deluxe™ Resilient Channels, 15.9 Fire-Shield C™ Gypsum Board
<b>Specimen Area</b>	10.98 m <sup>2</sup>
<b>Technician</b>	Daniel B. Mohler

**STC Rating**      **64**      (*Sound Transmission Class*)

**Deficiencies**      31      (*Sum of Deficiencies*)

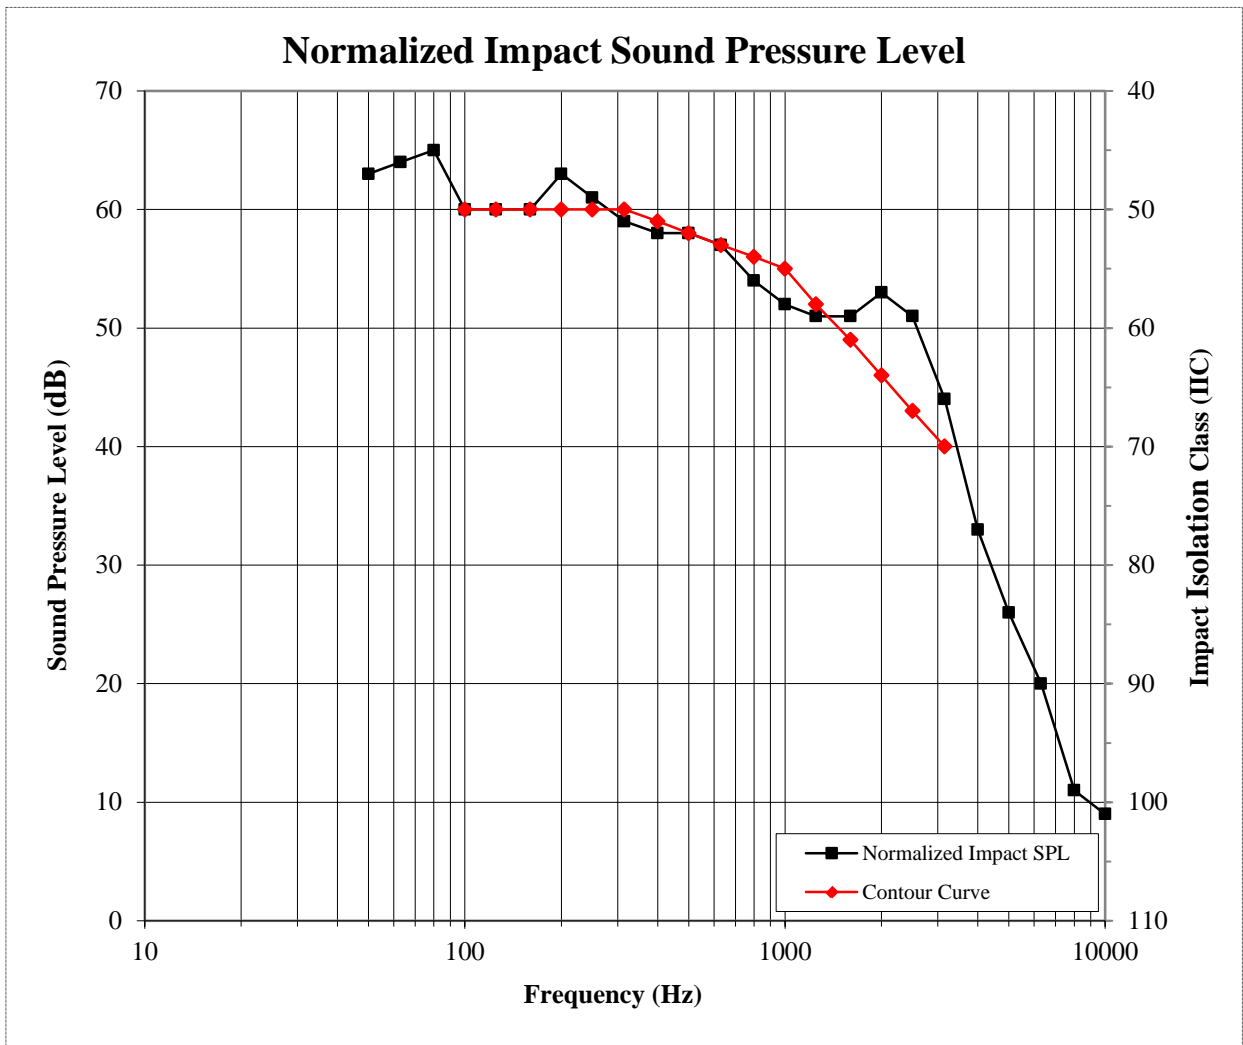
**IMPACT TRANSMISSION**  
ASTM E 492

<b>Test Date</b>	10/17/13
<b>Data File No.</b>	D0875.02A
<b>Client</b>	ECORE International
<b>Description</b>	7 mm Ceramic Tile, 8 mm Cement Board, 5 mm Ecore International QT4005 Underlayment, 18.3 mm T&G OSB Subfloor, 457 mm Open Web Truss, 165 mm R-19 Fiberglass Insulation, 13 mm RC Deluxe™ Resilient Channels, 15.9 Fire-Shield C™ Gypsum Board
<b>Specimen Area</b>	10.98 m <sup>2</sup>
<b>Technician</b>	Daniel B. Mohler

**IIC Rating**      **52**      *(Impact Insulation Class)*  
**Deficiencies**    **25**      *(Sum of Deficiencies)*

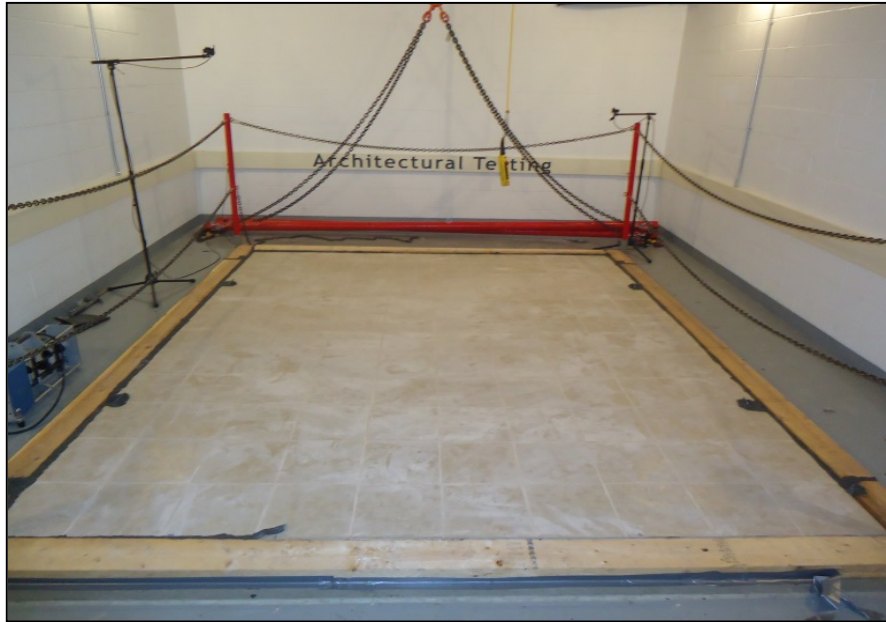
**Source Room View of Test Specimen Installation**

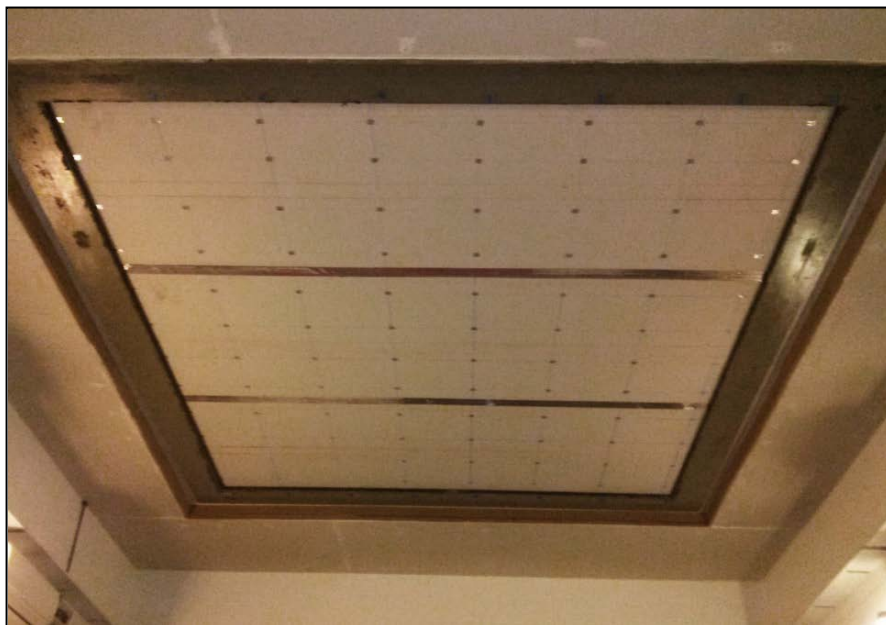
**Receive Room View of Test Specimen Installation**

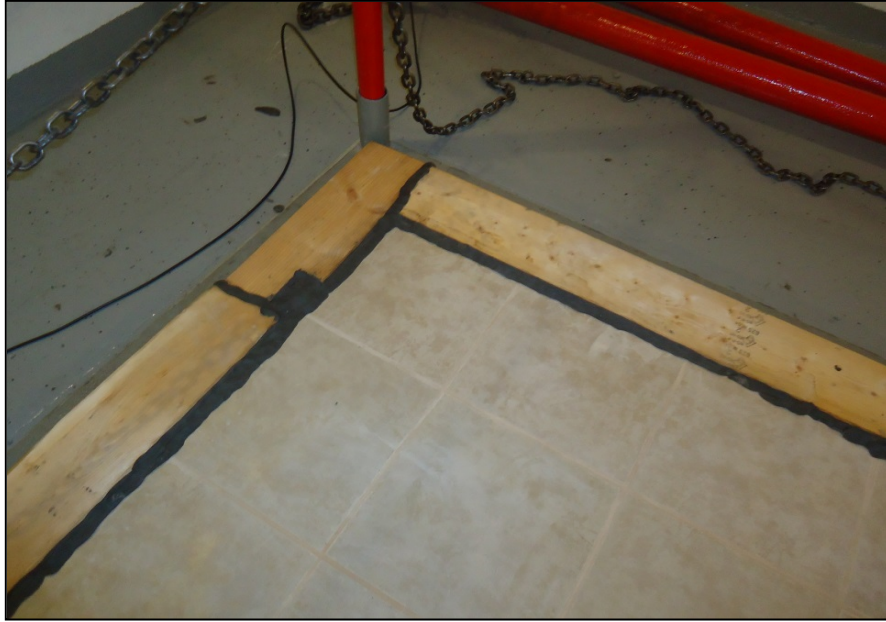
**Source Room View of Sample Corner**

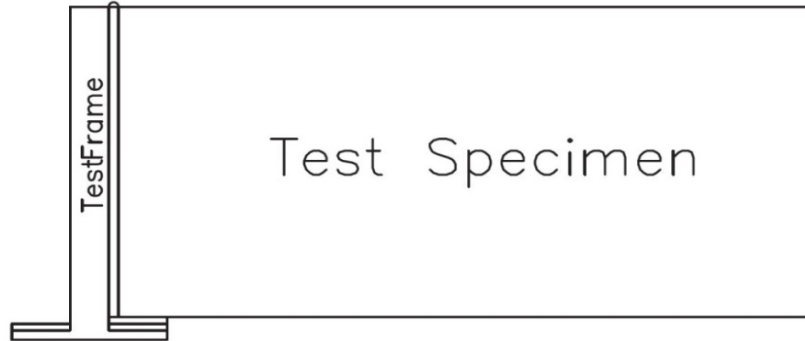
**Test Specimen Installation**

The floor/ceiling test specimen was constructed in the 3048 mm long by 3658 mm wide by 457 mm high steel frame test opening. A drawing of the installation details is included in the attachments.

Two rows of dense neoprene foam (9.5 mm thick by 76 mm wide) were adhered to the top of the steel test frame bottom flange. The floor/ceiling assembly was placed in the steel frame on top of the dense neoprene foam. The perimeter of the floor/ceiling assembly was sealed to the steel frame with duct seal.

An outer frame was constructed from 31.8 mm thick rim board. The rim board was reduced to a depth of 489 mm. The parallel chord trusses were hung with a JUS414 slant nail joist hanger on 610 mm center flush to the top of the outer frame.
