**C8707.02-113-11-R1**  
**ACOUSTICAL PERFORMANCE TEST REPORT**  
**ASTM E 90 AND ASTM E 492**

**Series/Model: QT4002**

**Specimen Type: Floor/Ceiling Assembly**

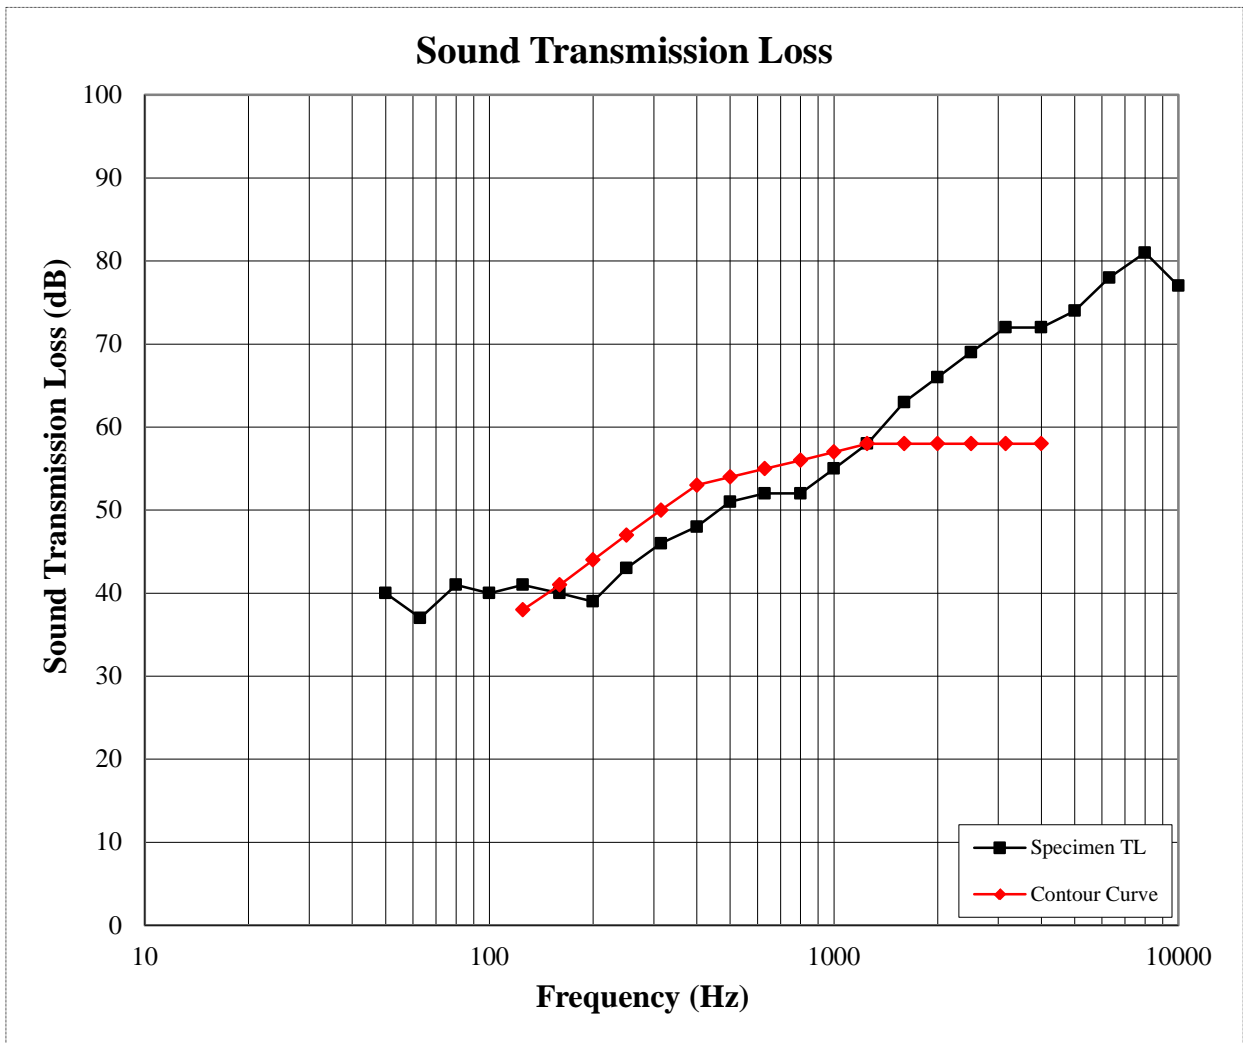
**SOUND TRANSMISSION LOSS**  
ASTM E 90

**STC Rating**      **54**      (*Sound Transmission Class*)

<b>Test Date</b>	06/06/13
<b>Data File No.</b>	C8707.01B
<b>Client</b>	ECORE International
<b>Description</b>	2.5 mm Polyflor Expona Luxury Vinyl Tile, 2 mm Ecore International QT4002 Rubber Underlayment, 150 mm Concrete Slab
<b>Specimen Area</b>	10.98 m <sup>2</sup>
<b>Technician</b>	Bradley D. Hunt

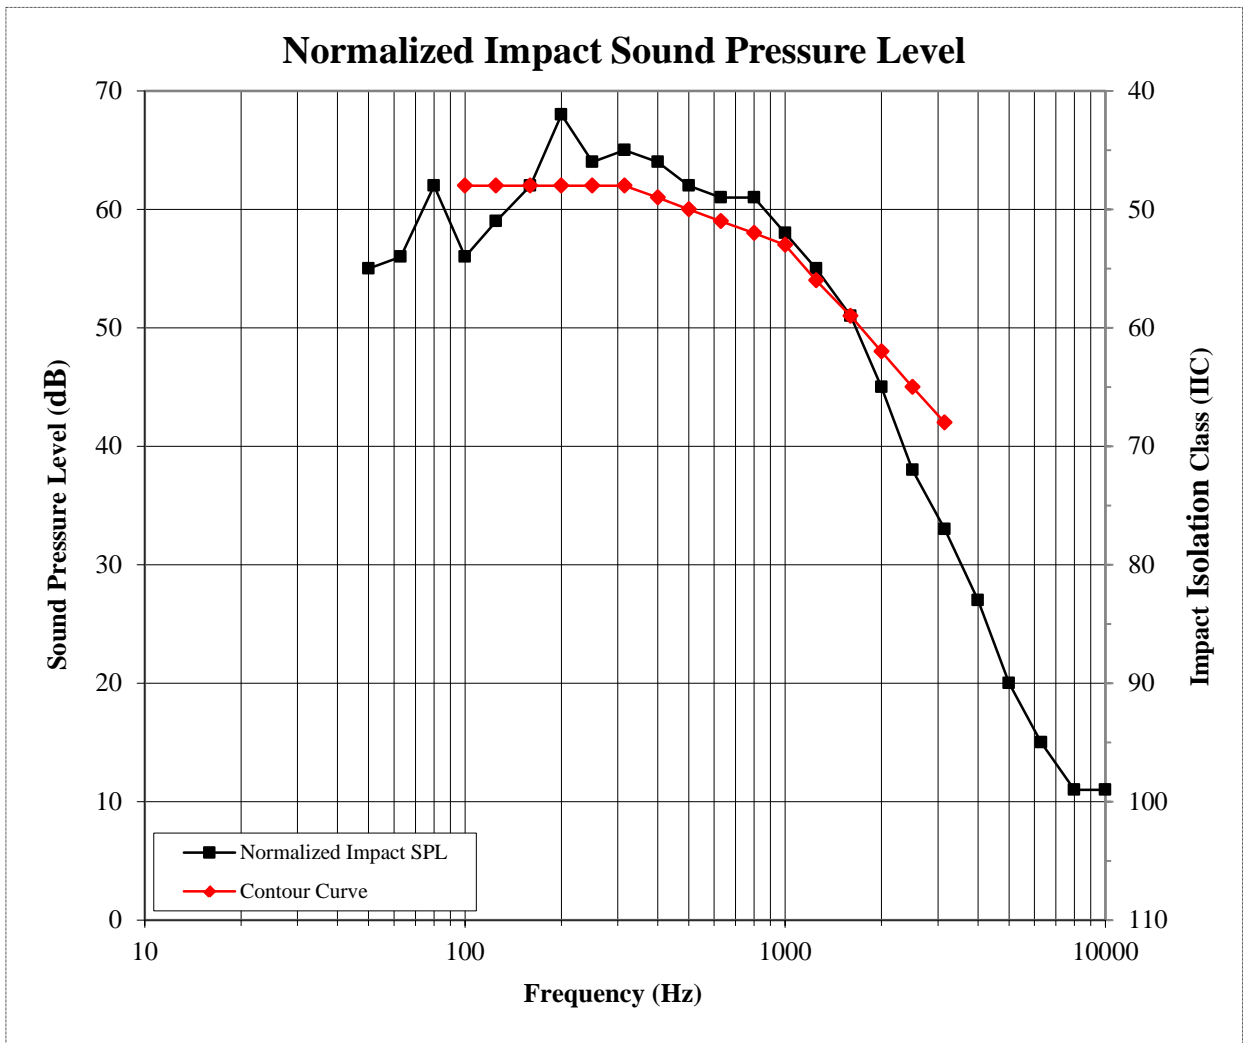
**IMPACT TRANSMISSION**  
 ASTM E 492

**IIC Rating**      **50**      (*Impact Insulation Class*)

<b>Test Date</b>	06/06/13
<b>Data File No.</b>	C8707.01B
<b>Client</b>	ECORE International
<b>Description</b>	2.5 mm Polyflor Expona Luxury Vinyl Tile, 2 mm ECORE International QT4002 Rubber Underlayment, 150 mm Concrete Slab
<b>Specimen Area</b>	10.98 m <sup>2</sup>
<b>Technician</b>	Bradlay D. Hunt

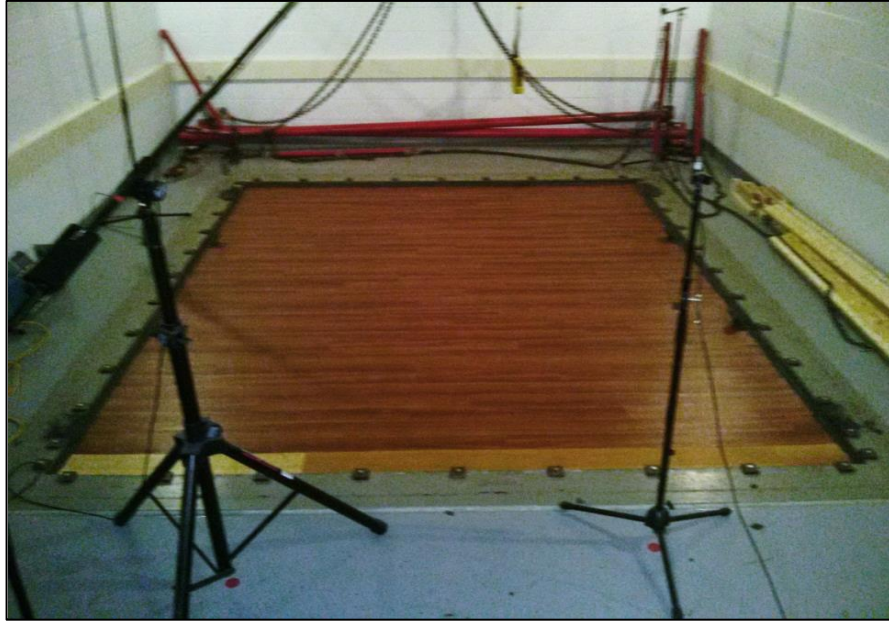
**Source Room View of Test Specimen Installation**

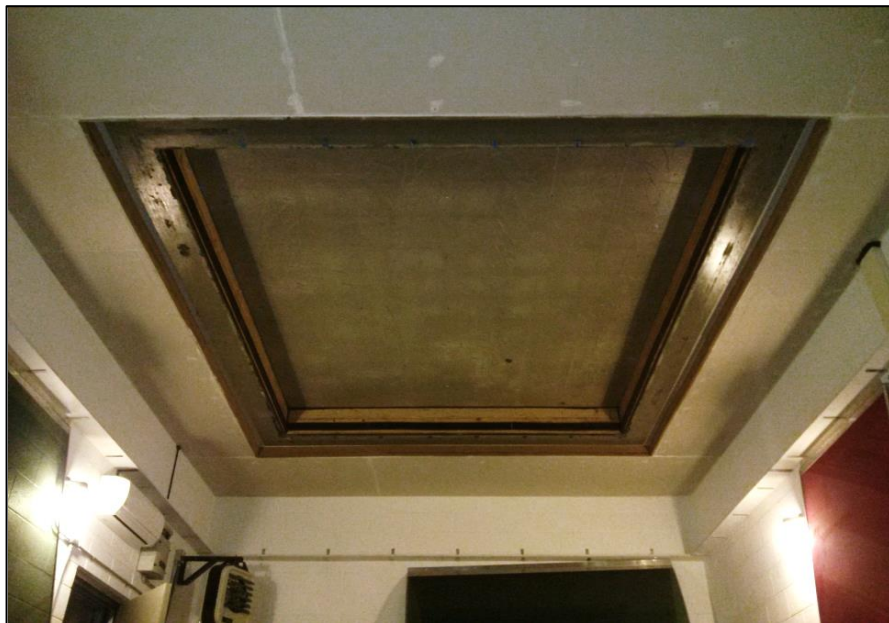
**Receive Room View of Test Specimen Installation**

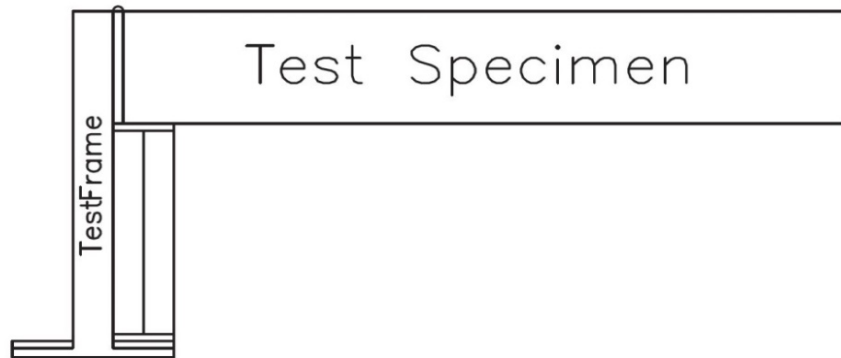
**Test Specimen Installation**

**Cross Section View of Test Specimen**

The test specimen was constructed in the 3023 mm long by 3632 mm wide by 457 mm high opening. A drawing of the test specimen installation is included in the attachments.

A single layer of 0.05 mm polyethylene sheet was adhered to the concrete. The Gerbert 2525 flooring adhesive was troweled over the protective layer using a 1.5 mm by 1.5 mm by 1.5 mm square notch trowel. A single layer of the QT4002 rubber underlayment was placed on top of the Gerbert 2525 flooring adhesive within one hour of application. A 100-pound roller was used to evenly compress the underlayment into the adhesive.

The Gerbert 2525 flooring adhesive was troweled over the underlayment using a 1.5 mm by 1.5 mm by 1.5 mm square notch trowel. A single layer of the Polyflor Expona luxury vinyl tile was installed on top of the Gerbert 2525 flooring adhesive within one hour of application. A 100-pound roller was used to evenly compress the flooring into the adhesive. The perimeter of the flooring was sealed with duct seal.
