### C8707.04-113-11-R1 ACOUSTICAL PERFORMANCE TEST REPORT ASTM E 90 AND ASTM E 492

**ECORE International**

Series/Model: QT4010

**Specimen Type: Floor/Ceiling Assembly**

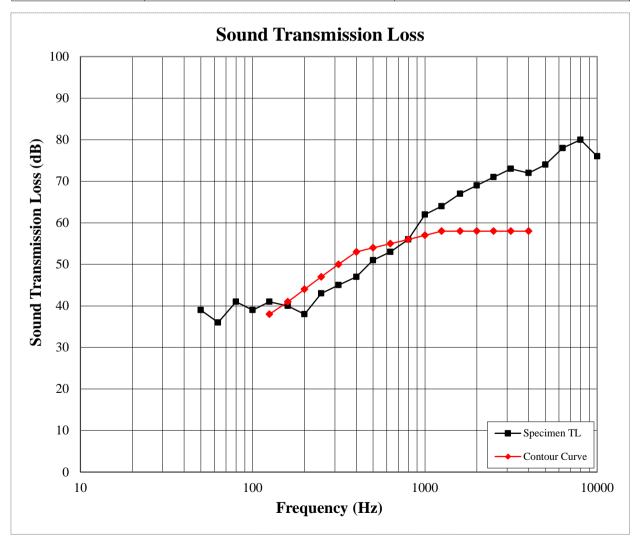
### SOUND TRANSMISSION LOSS

STC Rating 54 (Sound Transmission Class)

Test Date	06/12/13
Data File No.	C8707.01D
Client	ECORE International
Description	2.5 mm Polyflor Expona Luxury Vinyl Tile, 10 mm ECORE International QT4010
	Rubber Underlayment, 150 mm Concrete Slab
Specimen Area	10.98 m <sup>2</sup>
Technician	Bradlay D. Hunt

V	Background	A b a a 4 i a	Source	Receive	Specimen	95%	Number
Freq	SPL	Absorption	SPL	SPL	TL	Confidence	of
(Hz)	(dB)	(m²)	(dB)	(dB)	(dB)	Limit	<b>Deficiencies</b>
50	40.9	26.2	104	62	39	7.6	-
63	50.7	29.5	107	68	36	8.3	-
80	62.8	15.1	111	70	41	6.7	-
100	44.1	11.5	108	70	39	5.2	-
125	39.2	9.3	108	69	41	2.9	0
160	34.8	8.5	104	67	40	2.7	1
200	29.4	9.9	106	68	38	3.5	6
250	27.9	9.3	107	66	43	2.7	4
315	26.2	8.4	105	62	45	1.7	5
400	24.0	7.4	106	61	47	1.7	6
500	24.9	6.7	106	57	51	0.8	3
630	25.0	6.8	105	55	53	0.8	2
800	26.2	7.1	106	53	56	1.1	0
1000	26.0	7.0	106	48	62	1.2	0
1250	25.0	7.1	106	45	64	0.3	0
1600	21.3	7.2	107	43	67	0.9	0
2000	15.2	7.7	106	40	69	0.7	0
2500	11.6	8.6	105	37	71	0.6	0
3150	9.9	9.3	104	33	73	0.7	0
4000	7.6	10.2	103	32	72	1.0	0
5000	6.3	11.8	100	26	74	0.9	-
6300	6.2	15.1	95	17	78	0.8	-
8000	6.4	19.2	92	11	80	0.9	-
10000	6.4	24.6	86	8	76	0.8	-

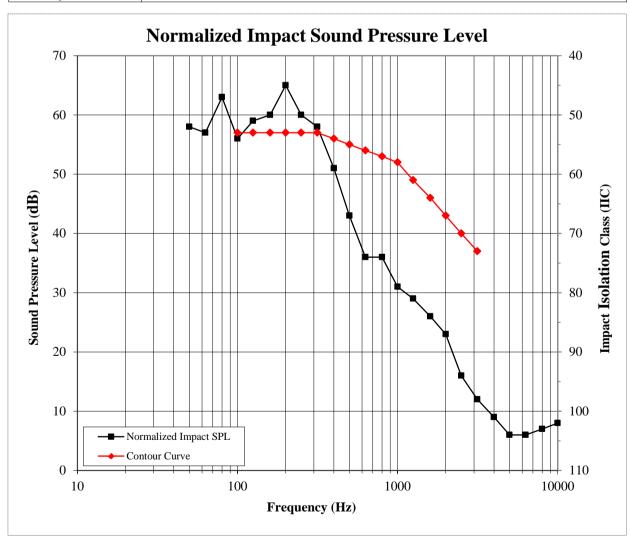
### **IMPACT TRANSMISSION**

IIC Rating55(Impact Insulation Class)Deficiencies17(Sum of Deficiencies)

Test Date	06/12/13
Data File No.	C8707.01D
Client	ECORE International
Description	2.5 mm Polyflor Expona Luxury Vinyl Tile, 10 mm ECORE International QT4010
	Rubber Underlayment, 150 mm Concrete Slab
Specimen Area	10.98 m <sup>2</sup>
Technician	Bradlay D. Hunt

T	D1 1 CDI	A 1	Normalized Impact	95%	Number
Freq	Background SPL	Absorption	SPL	Confidence	of
(Hz)	(dB)	$(m^2)$	(dB)	Limit	<b>Deficiencies</b>
50	39.8	26.7	58	3.3	-
63	50.2	26.4	57	3.6	-
80	62.4	15.1	63	3.9	-
100	42.2	11.6	56	2.1	0
125	38.6	9	59	2.0	2
160	33.7	8.6	60	1.5	2 3
200	29.1	10.1	65	3.6	8
250	29.1	9.3	60	2.7	3
315	26.0	8.4	58	4.3	1
400	23.3	7.3	51	6.5	0
500	24.9	6.7	43	7.4	0
630	25.9	6.8	36	3.9	0
800	28.3	7.1	36	2.2	0
1000	24.8	7	31	2.3	0
1250	23.5	7.1	29	1.5	0
1600	20.6	7.2	26	1.5	0
2000	14.1	7.8	23	1.4	0
2500	11.1	8.6	16	2.4	0
3150	8.8	9.3	12	3.0	0
4000	6.9	10.2	9	2.0	-
5000	6.0	11.8	6	0.9	-
6300	6.1	15.1	6 7	0.5	-
8000	6.4	19.2		0.3	-
10000	6.4	24.6	8	0.2	-

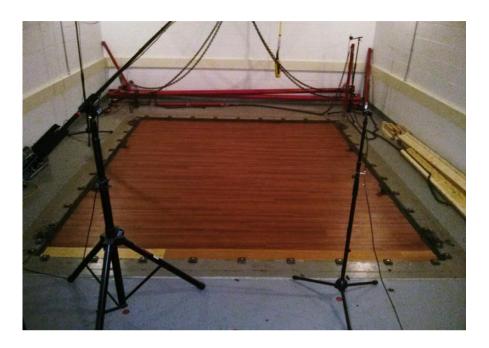
**Source Room View of Test Specimen Installation**

A single layer of 0.05 mm polyethylene sheet was adhered to the concrete. The Gerbert 2525 flooring adhesive was troweled over the protective layer using a 1.5 mm by 1.5 mm by 1.5 mm square notch trowel. A single layer of the QT4010 rubber underlayment was placed on top of the Gerbert 2525 flooring adhesive within one hour of application. A 100-pound roller was used to evenly compress the underlayment into the adhesive.

The Gerbert 2525 flooring adhesive was troweled over the underlayment using a 1.5 mm by 1.5 mm by 1.5 mm square notch trowel. A single layer of the Polyflor Expona luxury vinyl tile was installed on top of the Gerbert 2525 flooring adhesive within one hour of application. A 100-pound roller was used to evenly compress the flooring into the adhesive. The perimeter of the flooring was sealed with duct seal.

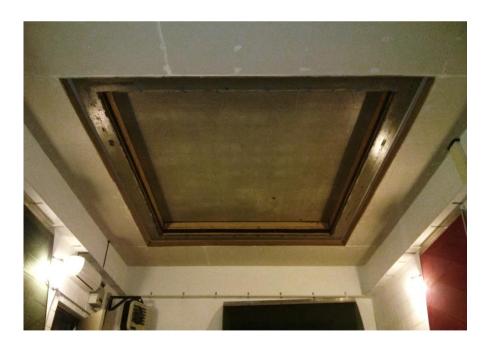
**Receive Room View of Test Specimen Installation**

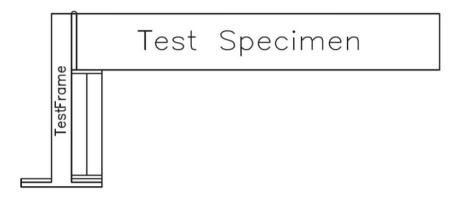
**Test Specimen Installation**

**Cross Section View of Test Specimen**

The test specimen was constructed in the 3023 mm long by 3632 mm wide by 457 mm high opening. A drawing of the test specimen installation is included in the attachments.

Material	Dimensions	Thickness	Manufacturer and Series	Quantity	Average Weight	Total Weight
Luxury Vinyl Tile	152 mm by 914 mm	2.51 mm	Polyflor Expona	10.98 m²	4.4 kg/m²	48.3 kg
Rubber Underlayment	3023 mm by 1219 mm	9.8 mm	ECORE International QT4010	10.98 m²	7.7 kg/m²	84.5 kg
Concrete Slab	3023 mm by 3632 mm	150 mm	N/A	10.98 m²	366.2 kg/m²	4020.9 kg
